Project Name: Gold King Mine	Site Location: Silverton, San Juan County, Colorado	Project No. 0001/1408-01
--	---	------------------------------------

PHOTOGRAPH LOG

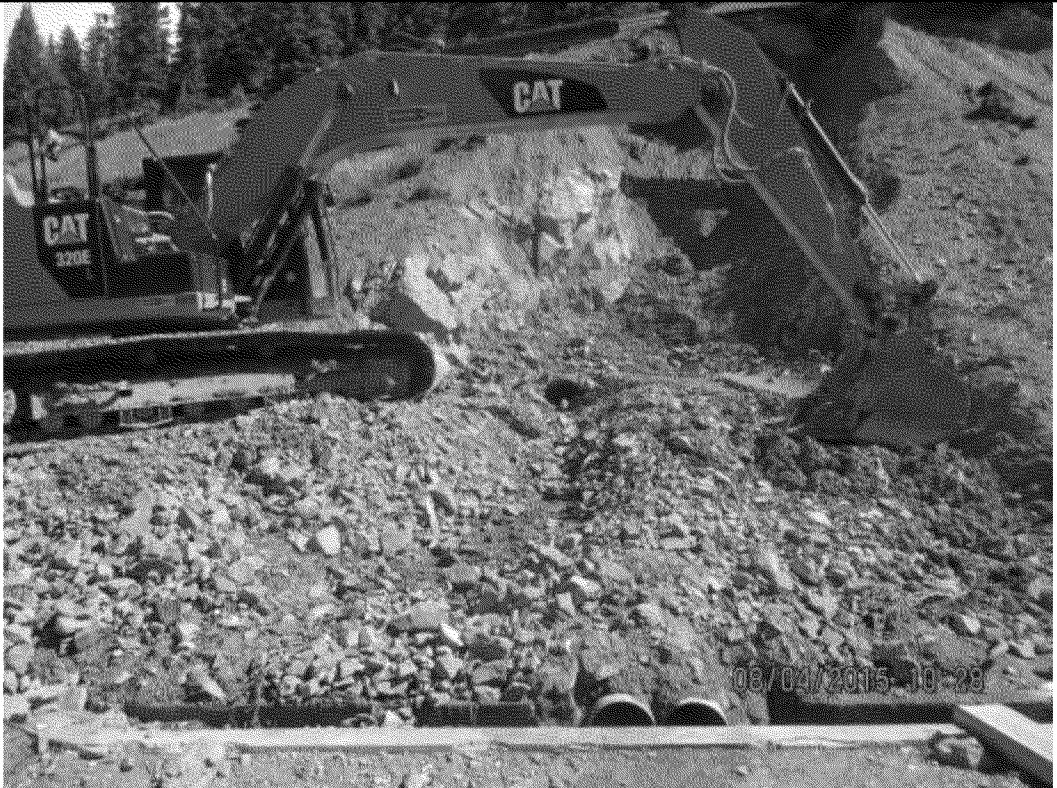
Photo No. 1	Date: 08/04/2015

Direction Photo Taken: North		
Description: Beginning investigation into collapsed adit.

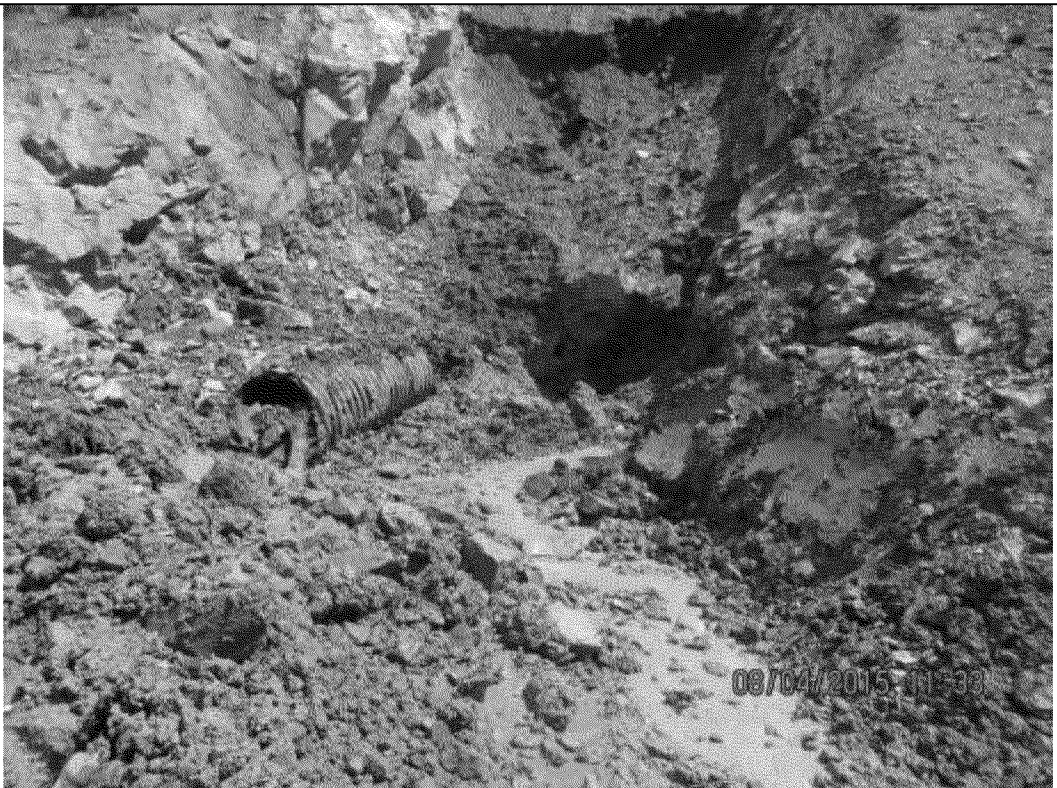
Photo No. 2	Date: 08/04/2015

Direction Photo Taken: North		
Description: Excavated next to DRMS-installed culvert, water muddy from soil disturbance.

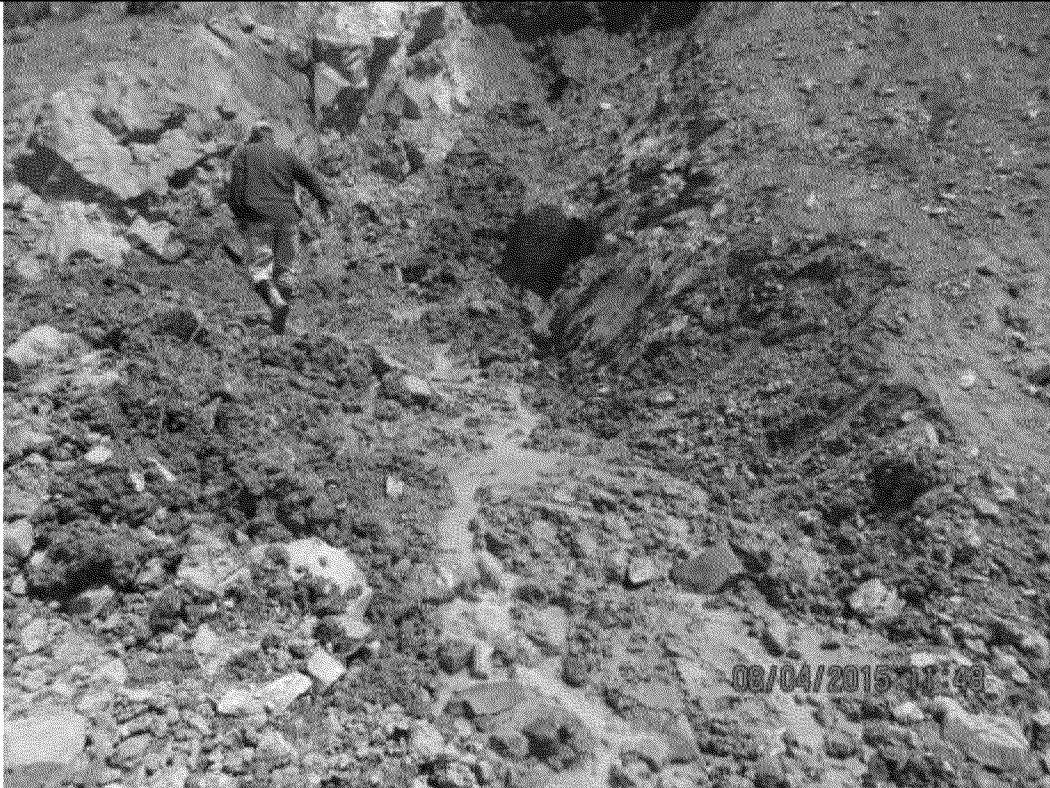
<p>Photo No. 5</p>	<p>Date: 08/04/2015</p>

<p>Direction Photo Taken:</p> <p>North</p>		
<p>Description:</p> <p>DRMS looking at adit excavation progress.</p>		
<p>Photo No. 6</p>	<p>Date: 08/04/2015</p>

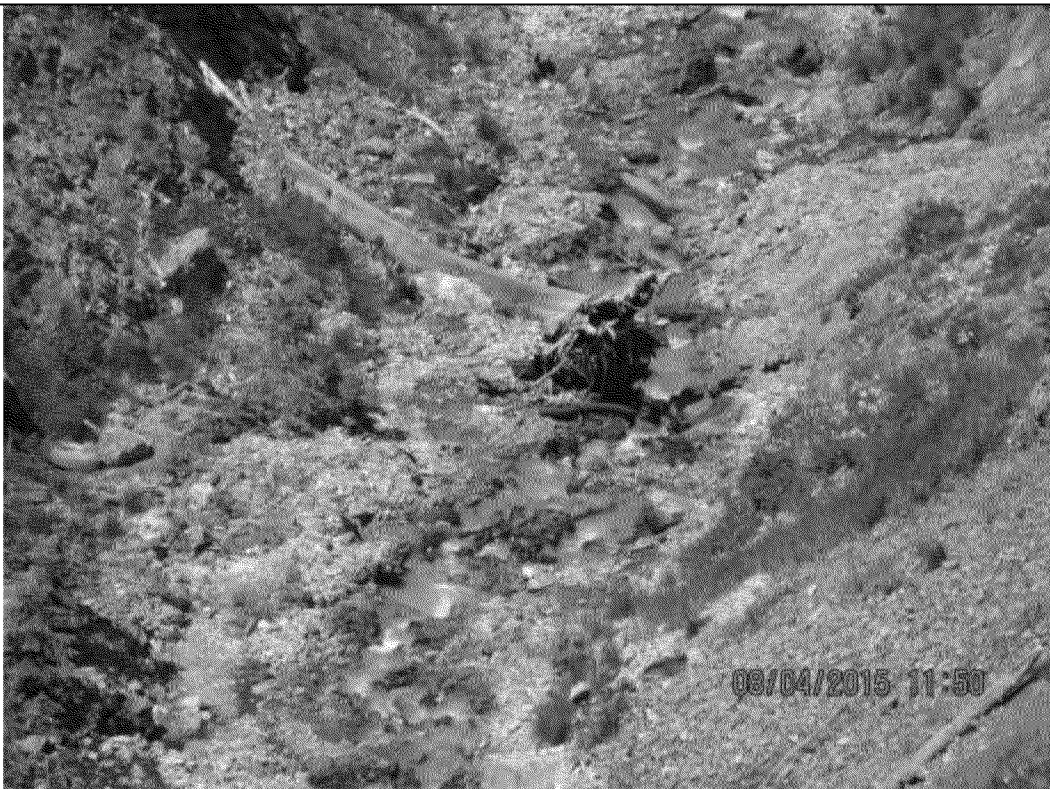
<p>Direction Photo Taken:</p> <p>West</p>		
<p>Description:</p> <p>Water minimally murky from disturbed soil and water entering the North Fork from site.</p>

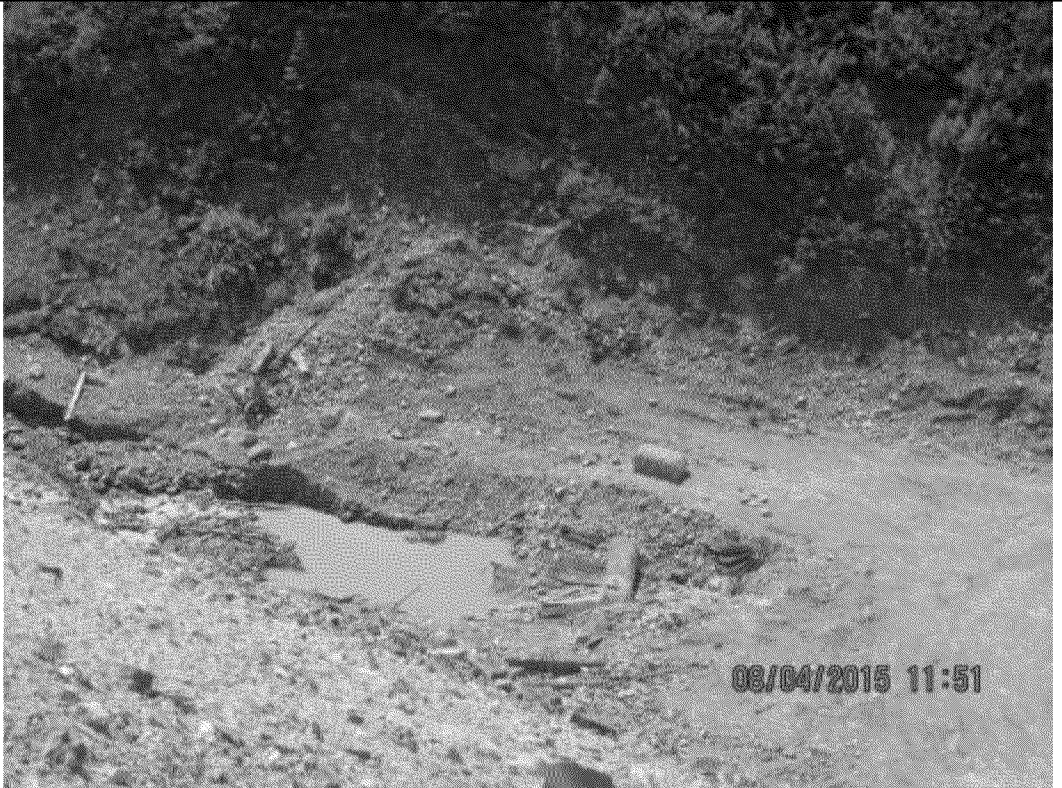
Photo No. 7	Date: 08/04/2015

Direction Photo Taken: South/Down		
Description: Hay bales installed as filter for sediment in North Fork.		
Photo No. 8	Date: 08/04/2015

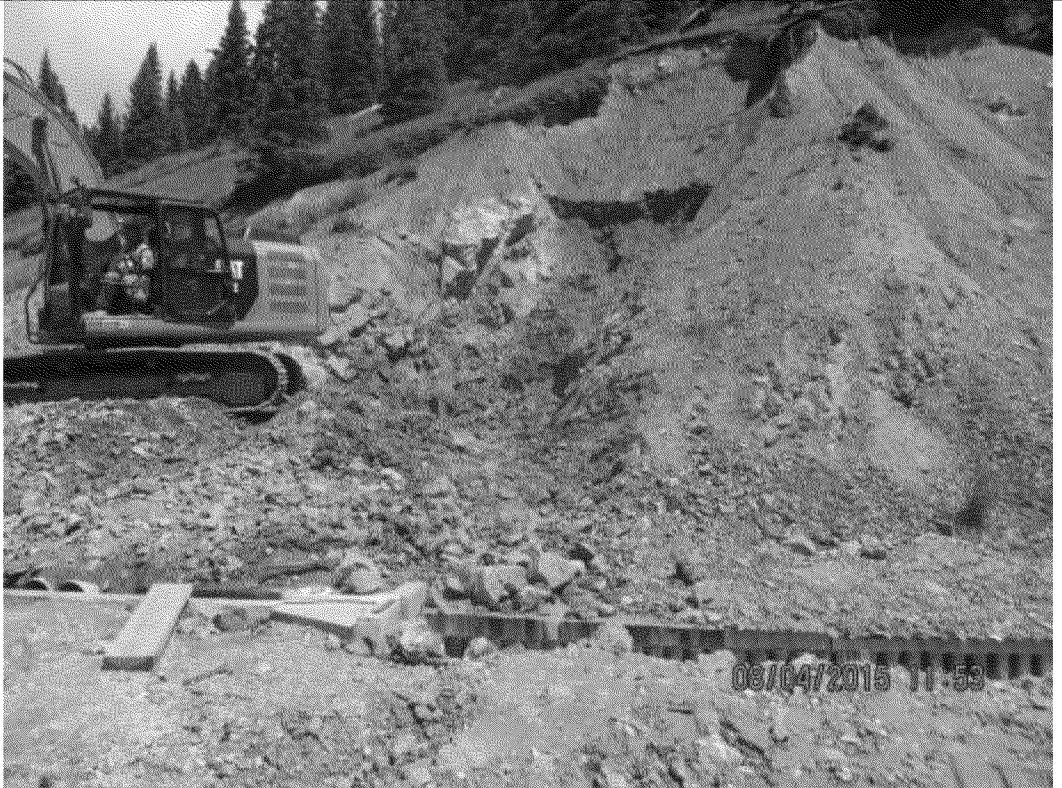
Direction Photo Taken: Northwest		
Description: Continuing excavation at the collapsed adit, no solid bedrock found for tunnel support.

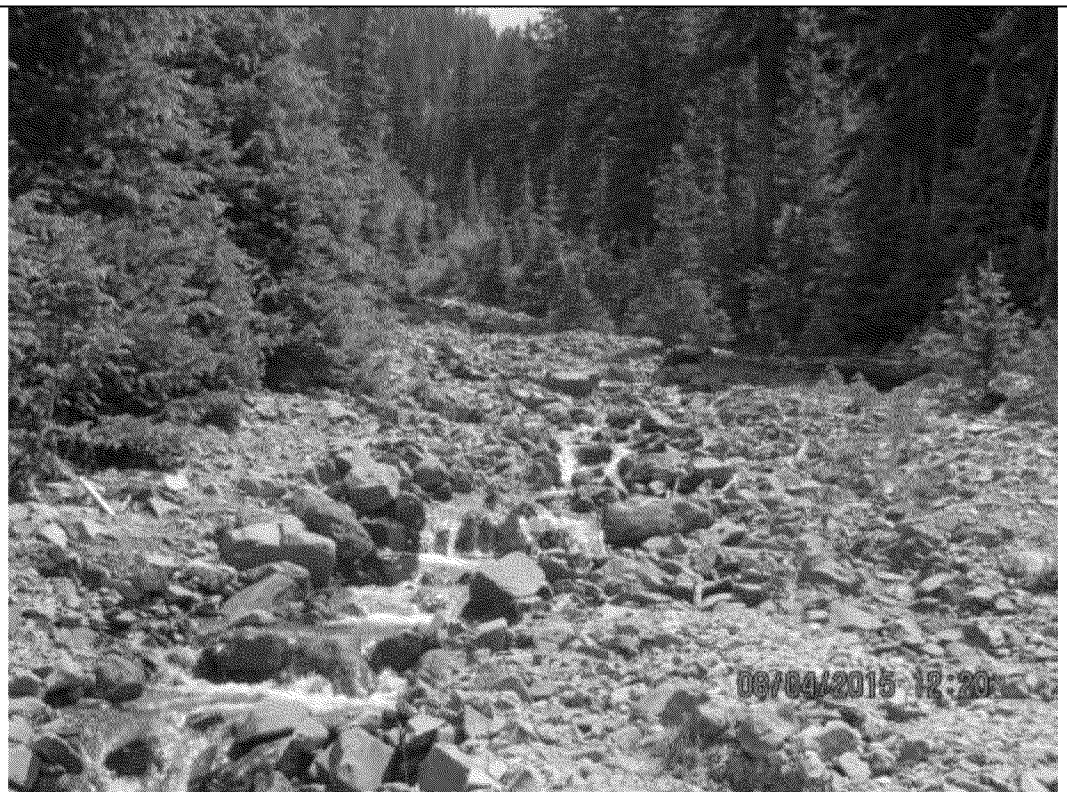
**Photo
No.
10**

Water of the North Fork
just upstream of
Cement Creek.

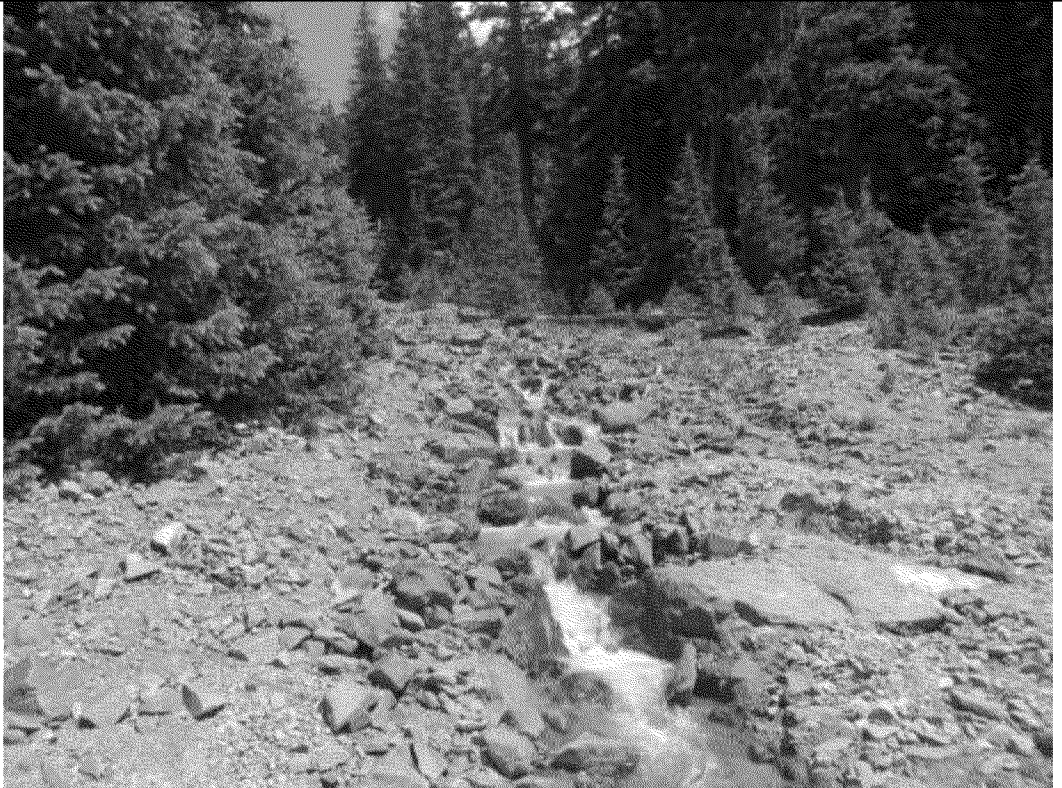
Photo No. 11	Date: 08/04/2015

Direction Photo Taken: East		
Description: Water of the North Fork just upstream of Cement Creek.		
Photo No. 12	Date: 08/04/2015

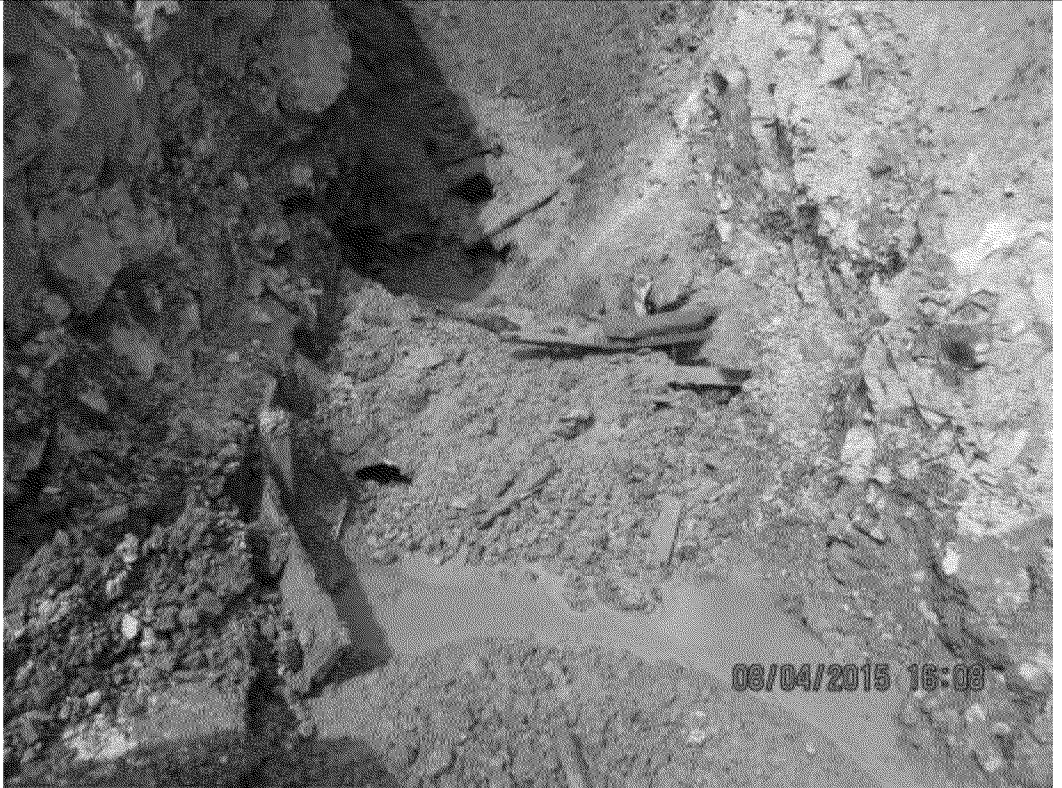
Direction Photo Taken: North		
Description: Collapsed supports uncovered above anticipated adit, no sign of bedrock above the adit area.

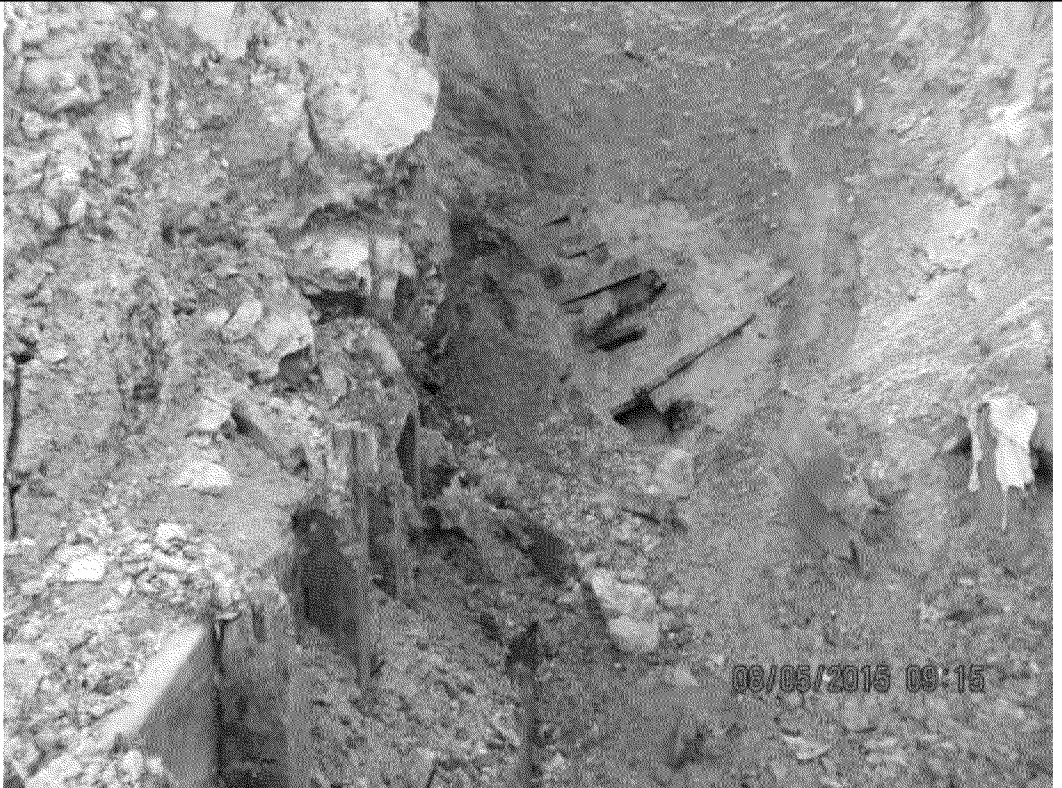
Photo No. 13	Date: 08/05/2015

Direction Photo Taken: North		
Description: Adit conditions the morning of 8/5.		
Photo No. 14	Date: 08/05/2015

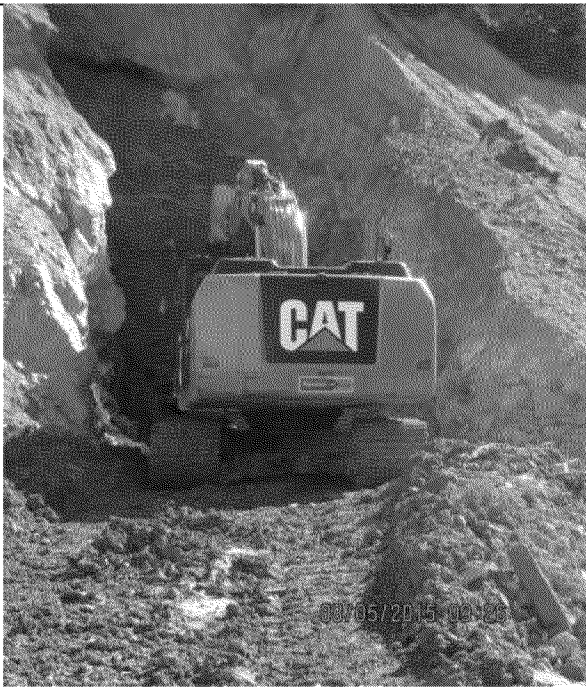
Direction Photo Taken: Northeast		
Description: Excavating material above the collapsed adit.

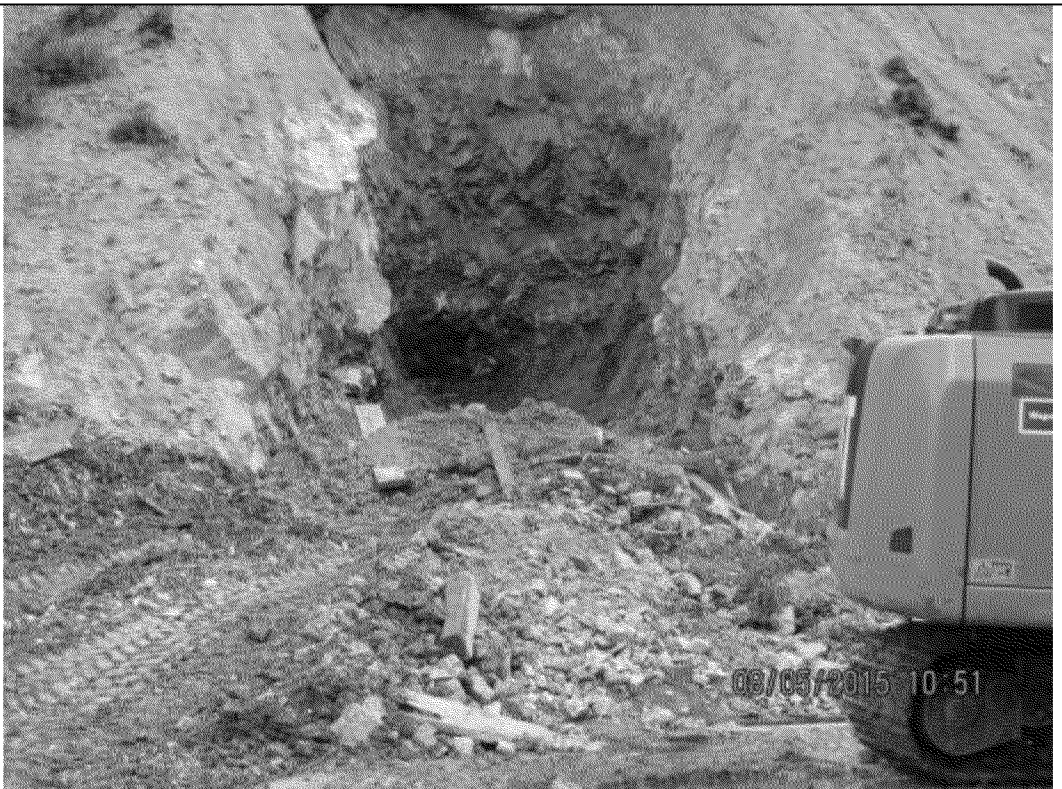
Direction Photo Taken: North		
Description: Cleaning out excavated material, small leak.

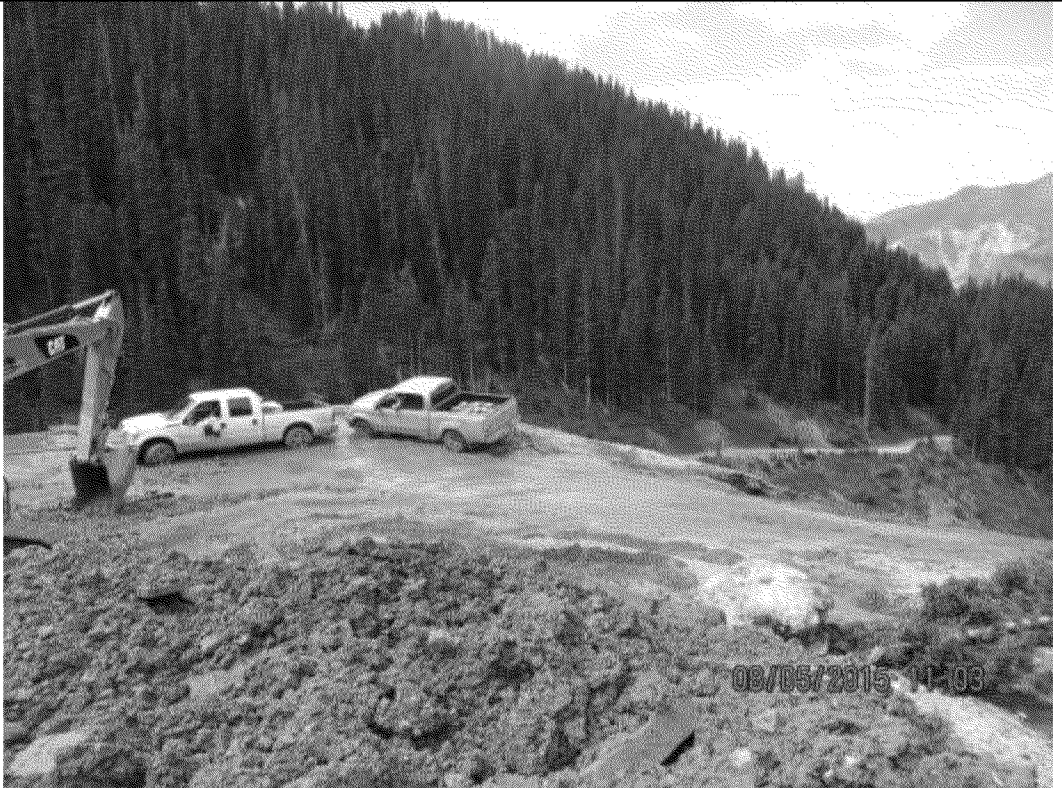
Photo No. 23	Date: 08/05/2015

Direction Photo Taken: Southwest		
Description: Exit route starting to collapse

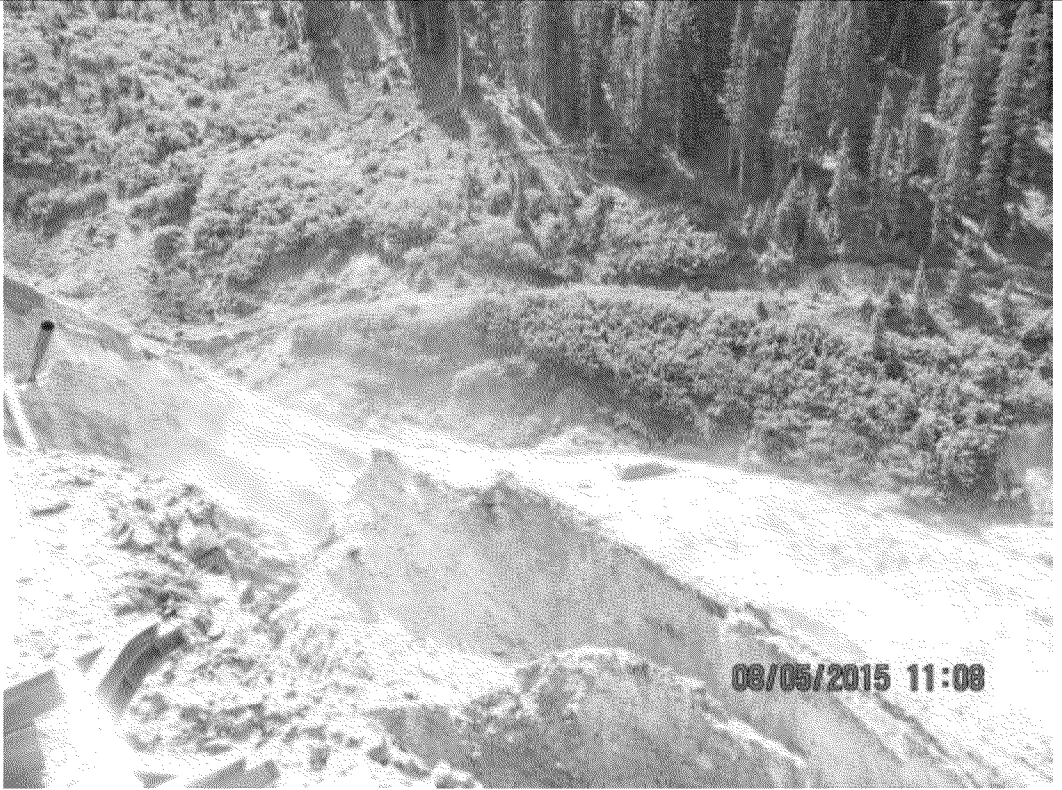
Photo No. 24	Date: 08/05/2015

Direction Photo Taken: Southeast/Down		
Description: Edge of the tailings dump collapsed, suburban trapped and half submerged in center of photo.

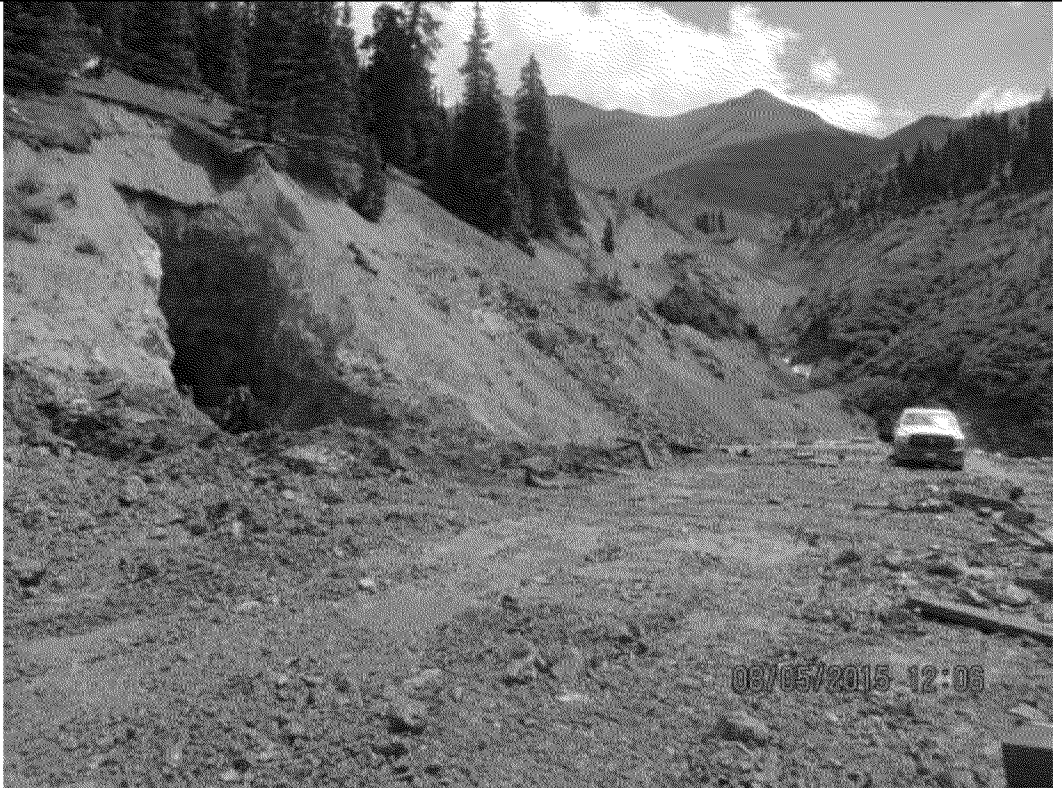
Photo No. 31	Date: 08/05/2015

Direction Photo Taken: Northeast		
Description: Adit area after regrading.		
Photo No. 32	Date: 08/05/2015

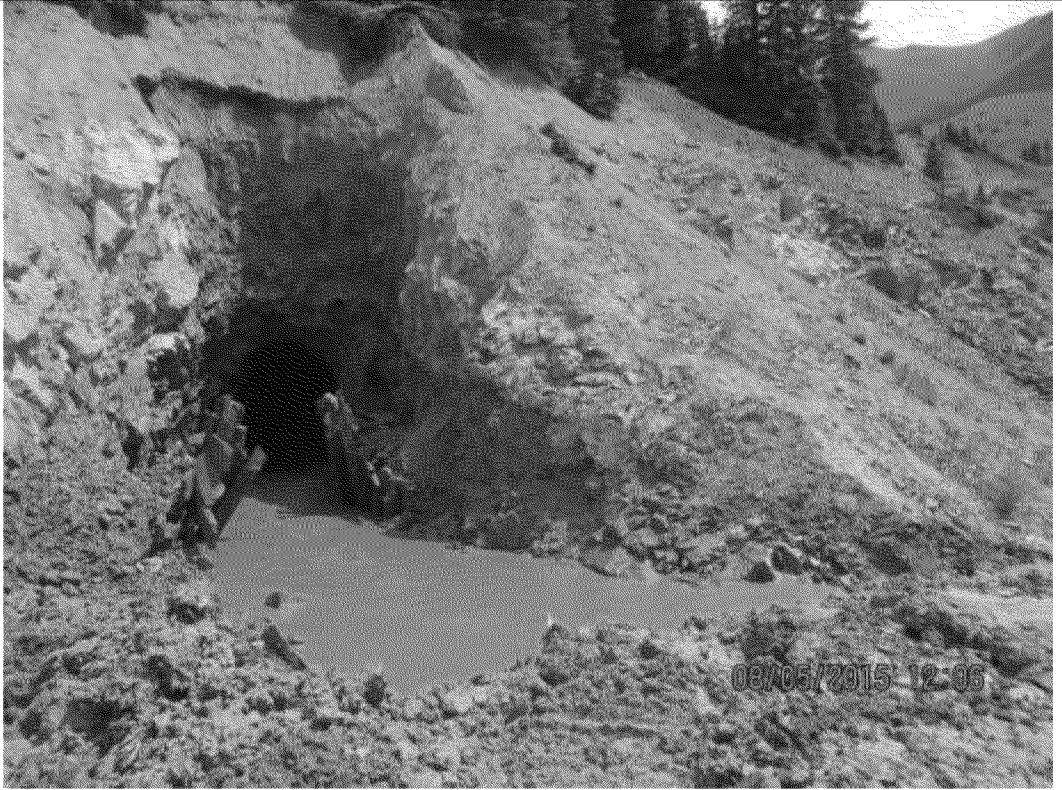
Direction Photo Taken: North		
Description: Exposed adit and redirected flow, flow is beginning to subside.

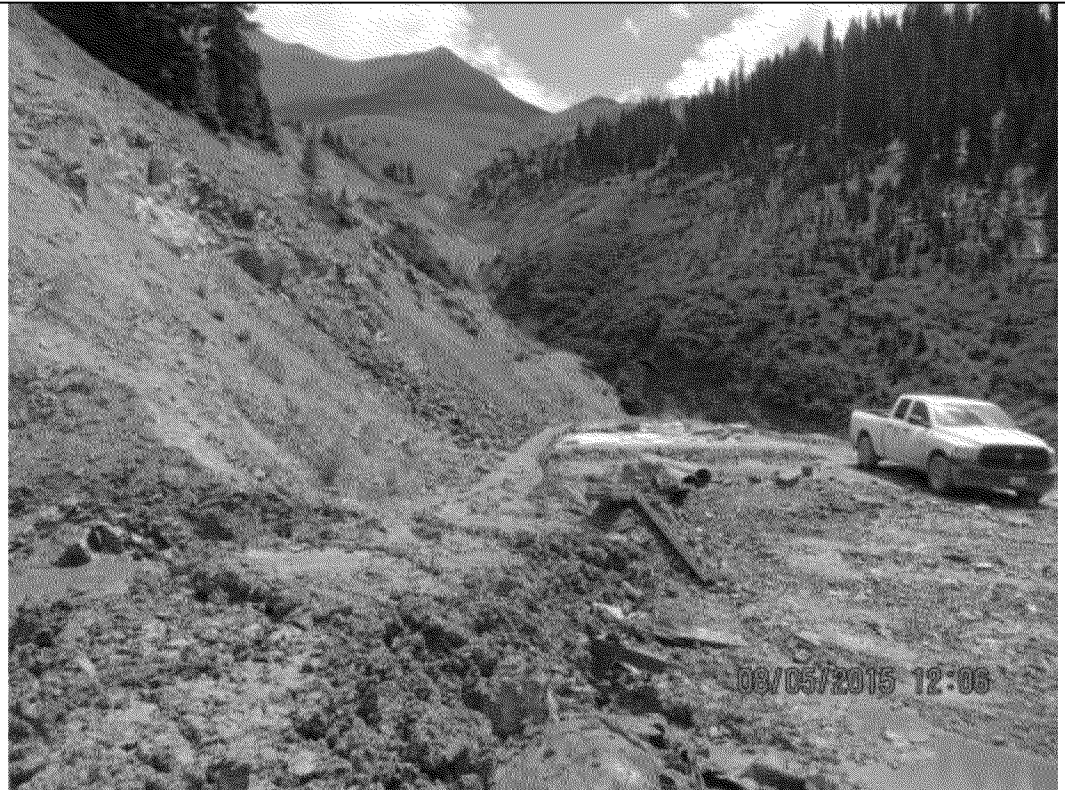
Photo No.
33

Redirected flow into existing half culvert channel.

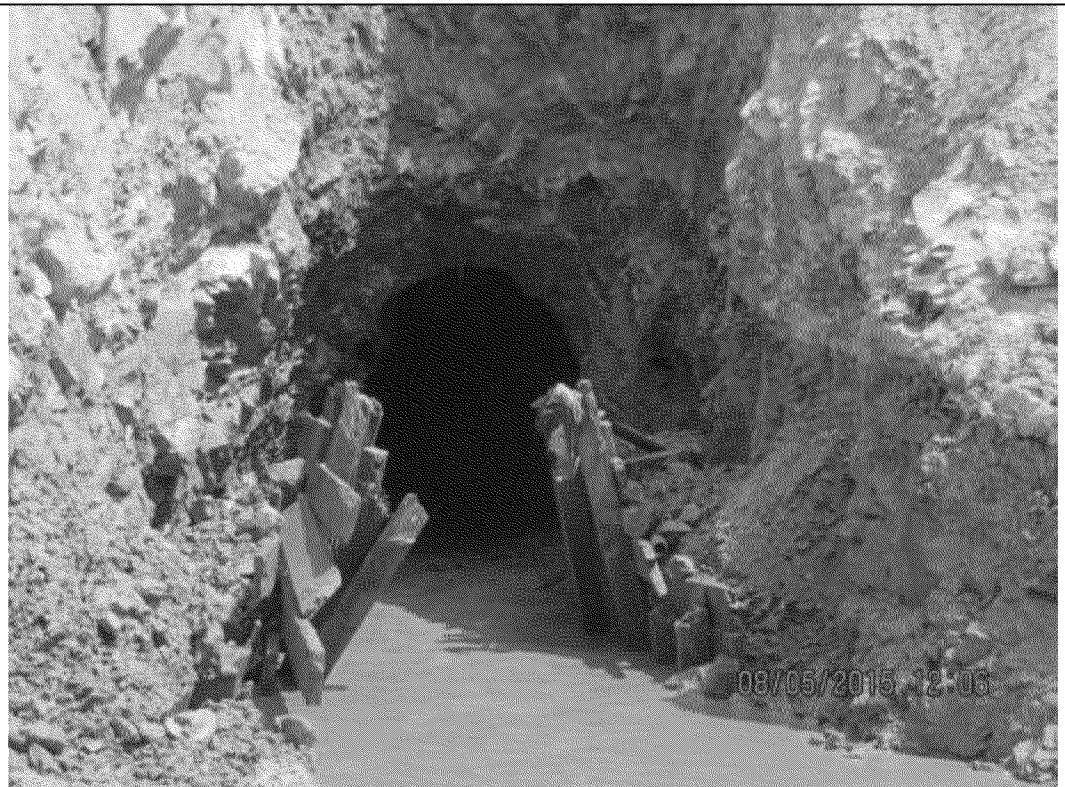
Photo No.
34

Closeup of adit.

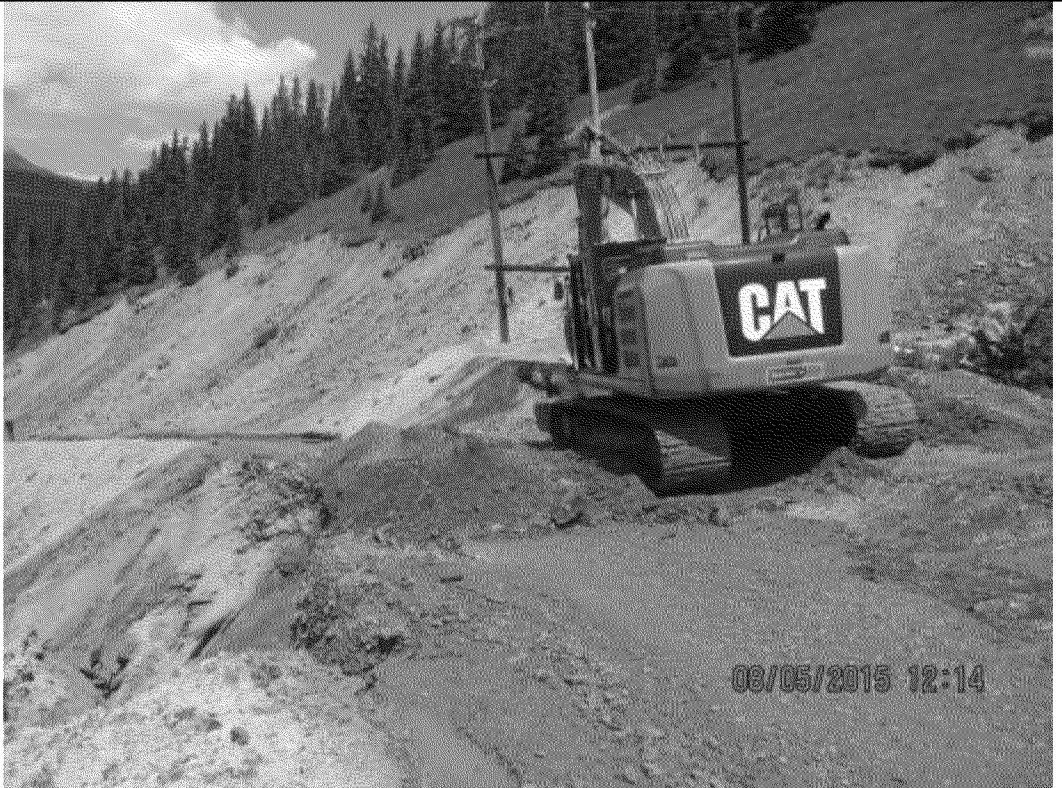
Photo No. 35	Date: 08/05/2015

Direction Photo Taken: West		
Description: Excavator beginning work to secure safe exit route for equipment, vehicles, and personnel.		
Photo No. 36	Date: 08/05/2015

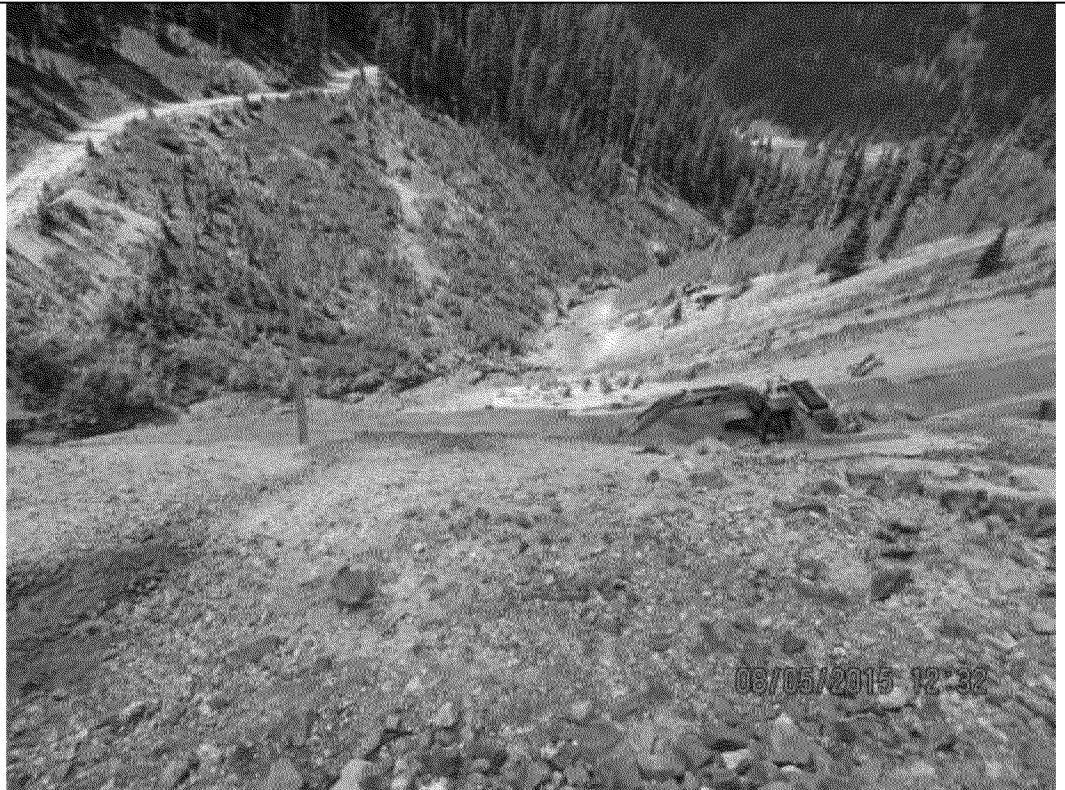
Photo No.
37

Excavator progress on fixing access road to create a safe exit route.

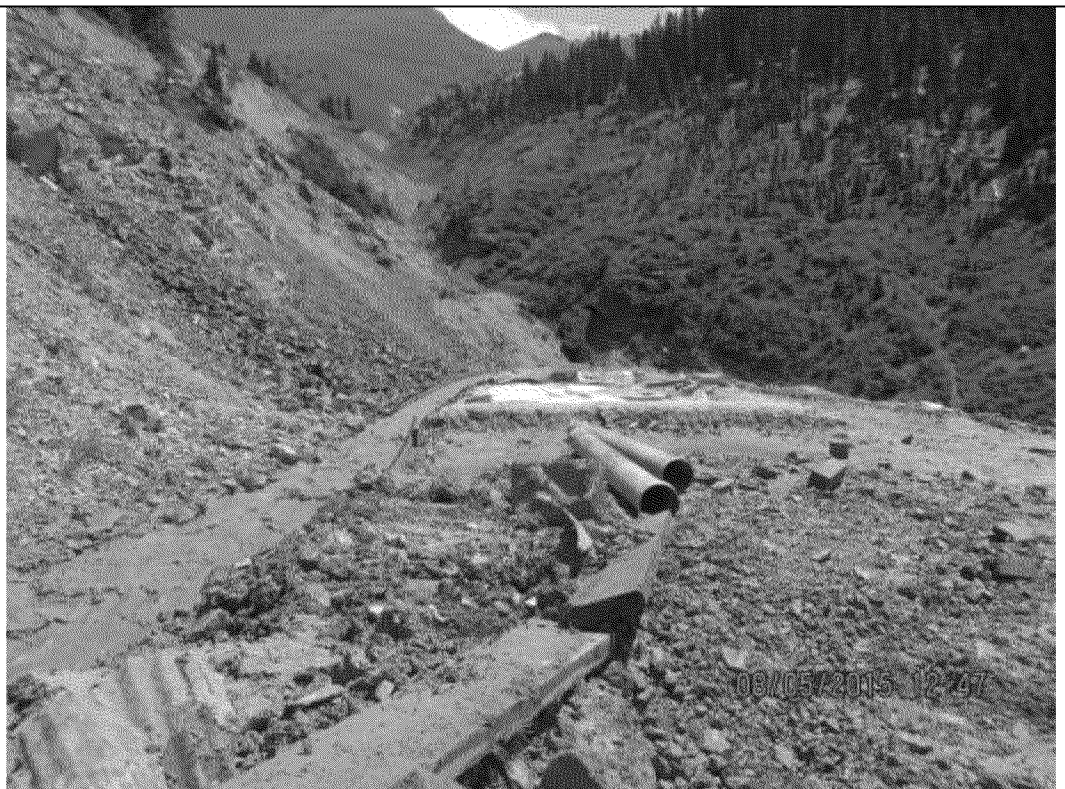
Photo No.
38

Existing culvert flows subsiding minimally.

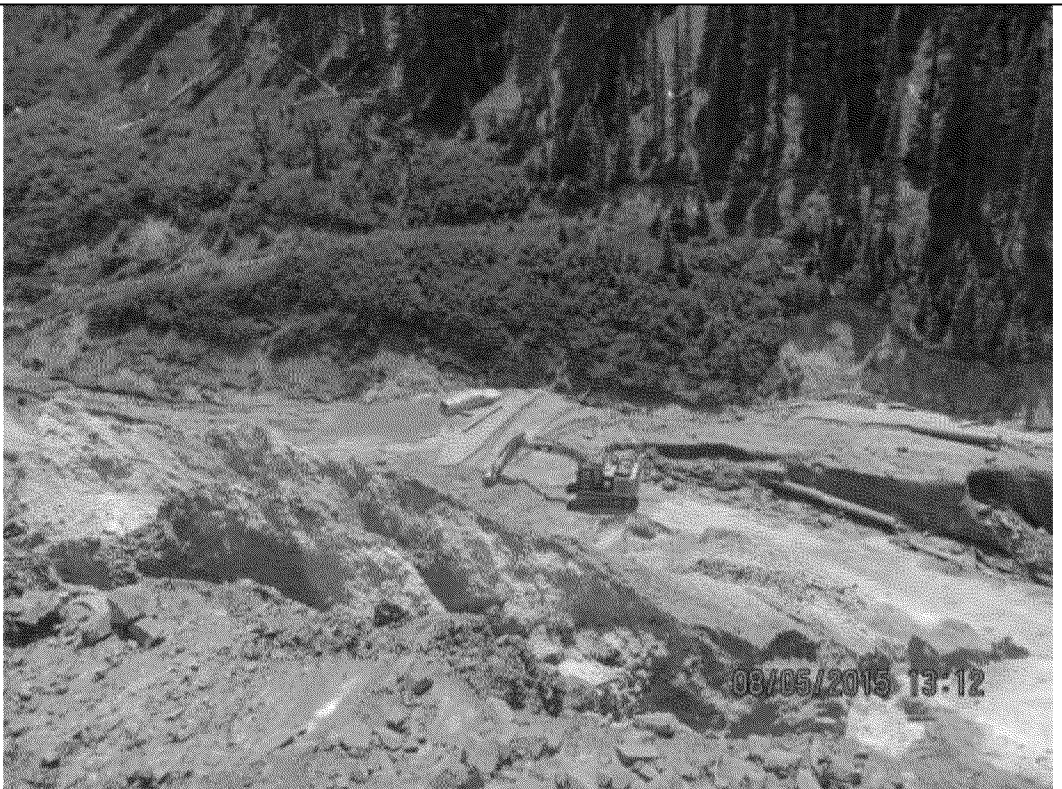
Direction Photo Taken: South/Down		
Description: Excavator progresses to washed out North Fork crossing.

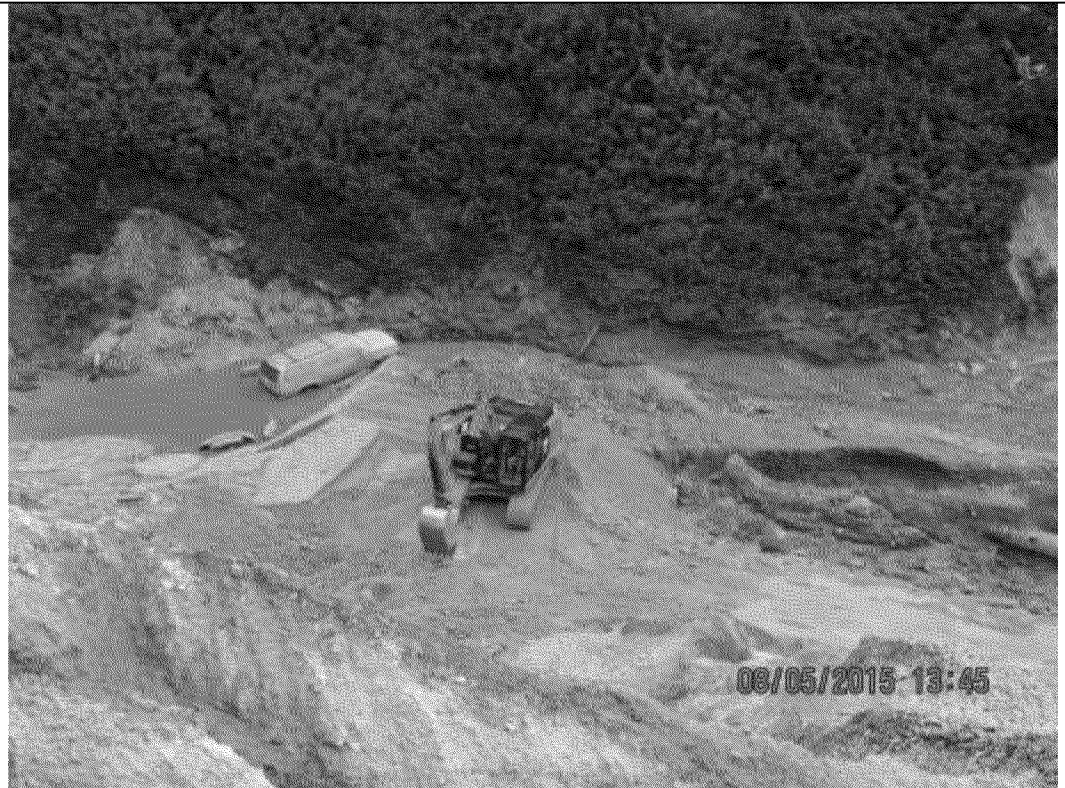
Photo No.
43

Excavator continues to fix access road.
Continued high flow is slowing progress.

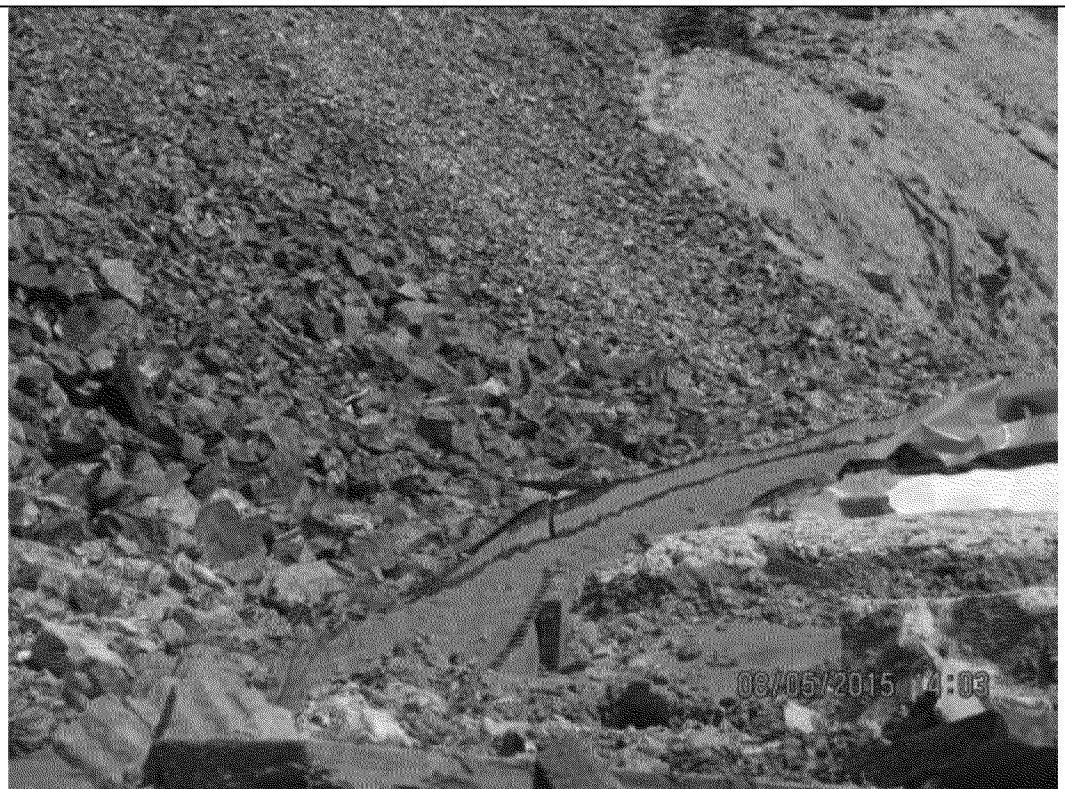
Photo No.
44

Half culvert flow continues to subside.

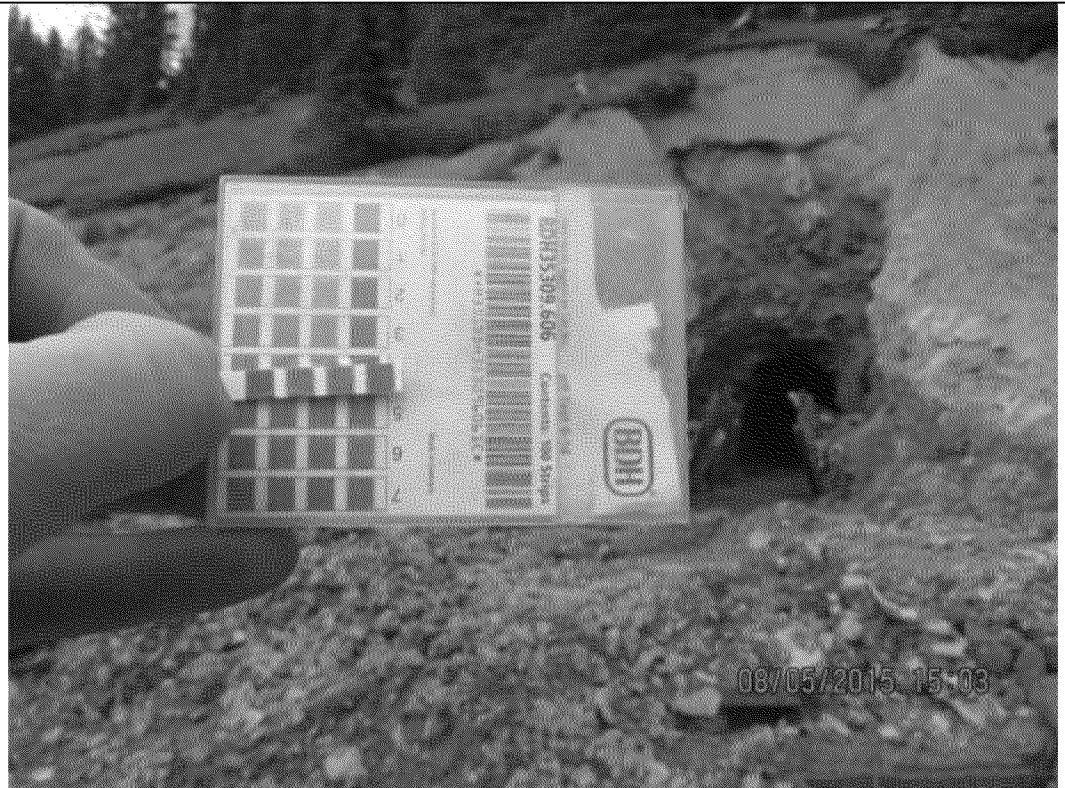
Photo No.
49

pH measured at approximately 4.5.

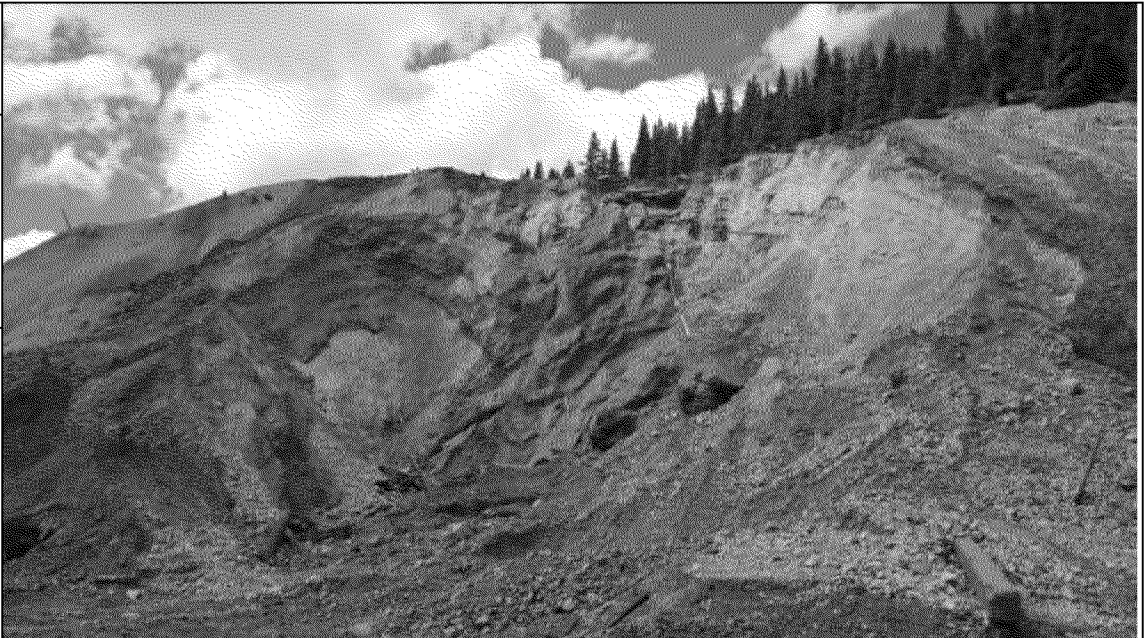
Photo No. 51	Date: 08/05/2015

Direction Photo Taken: North		
Description: Looking up from the toe of the Gold King waste dump directly south of the adit.

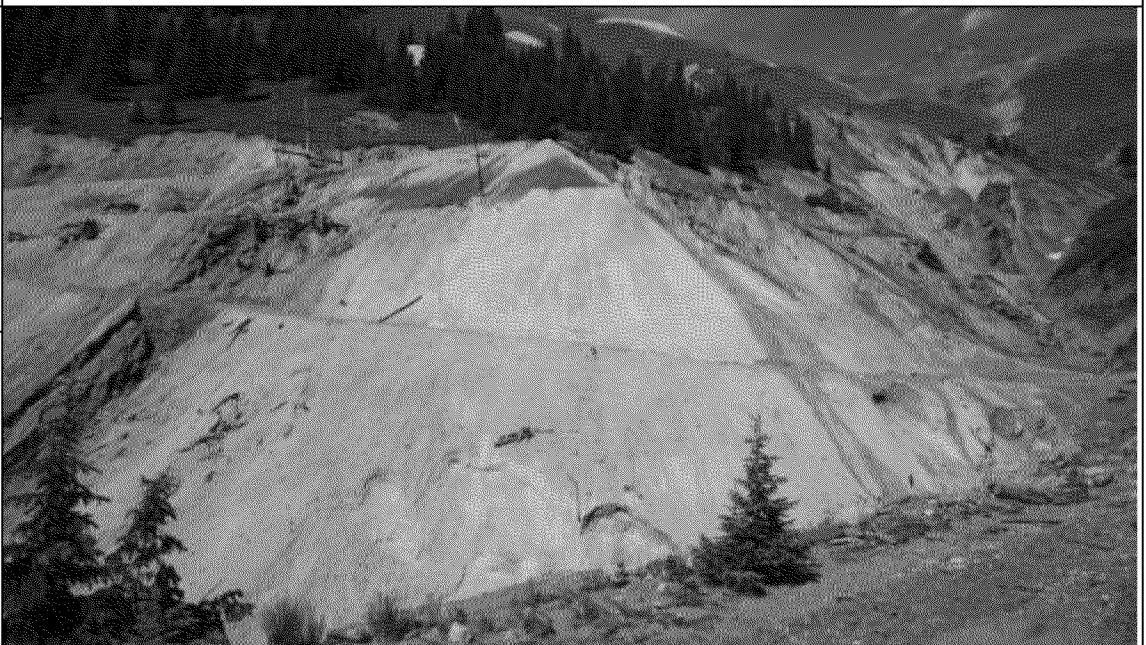
Photo No. 52	Date: 08/05/2015

Direction Photo Taken: Northeast		
Description: Gold King Mine tailings dump after water discharge.
